UNITED STATES ENVIRONMENTAL PROTECTION AGENCY REGION 8

POLREP 1

REMOVAL SITE EVALUATION

Subject: Red and Bonita Mine Site

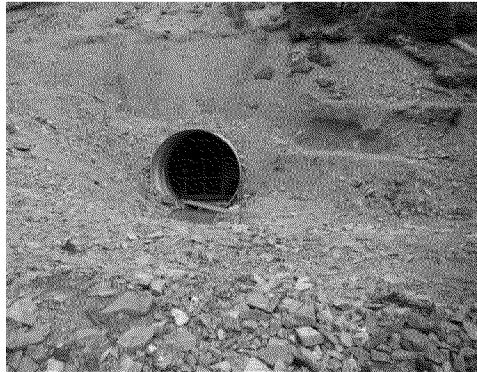
New mine portal, 2011

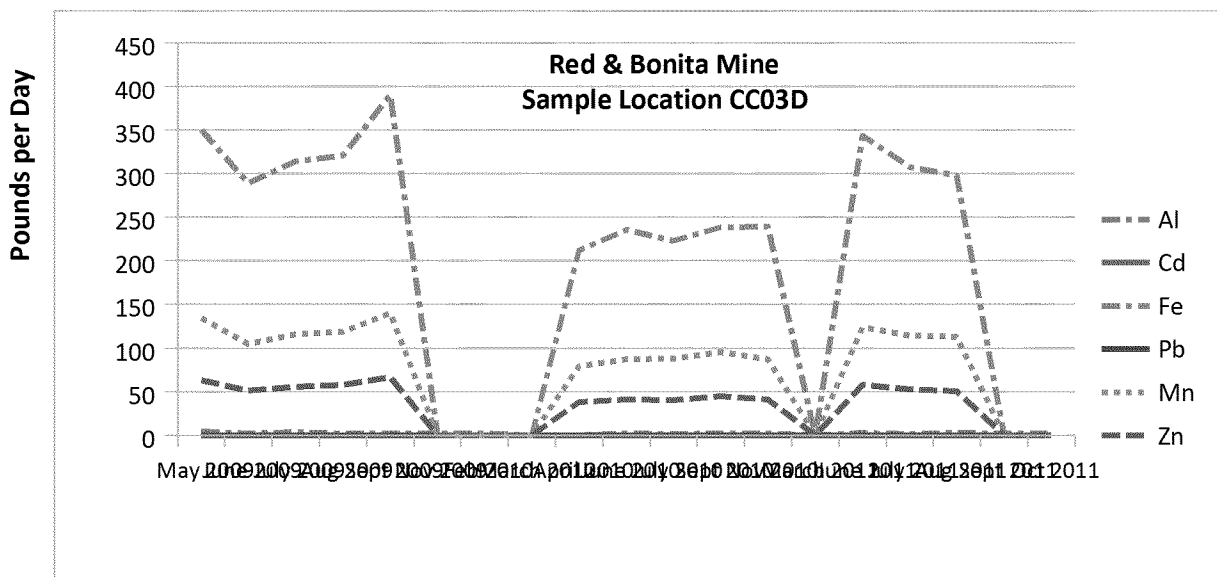
CC03D located at toe of mine dump in channelized mine discharge flow.
